Report No. CG-D-01-99, I

**Investigation of Fuel Oil/Lube Oil Spray Fires
On Board Vessels**

Volume I

**FINAL REPORT
NOVEMBER 1998**

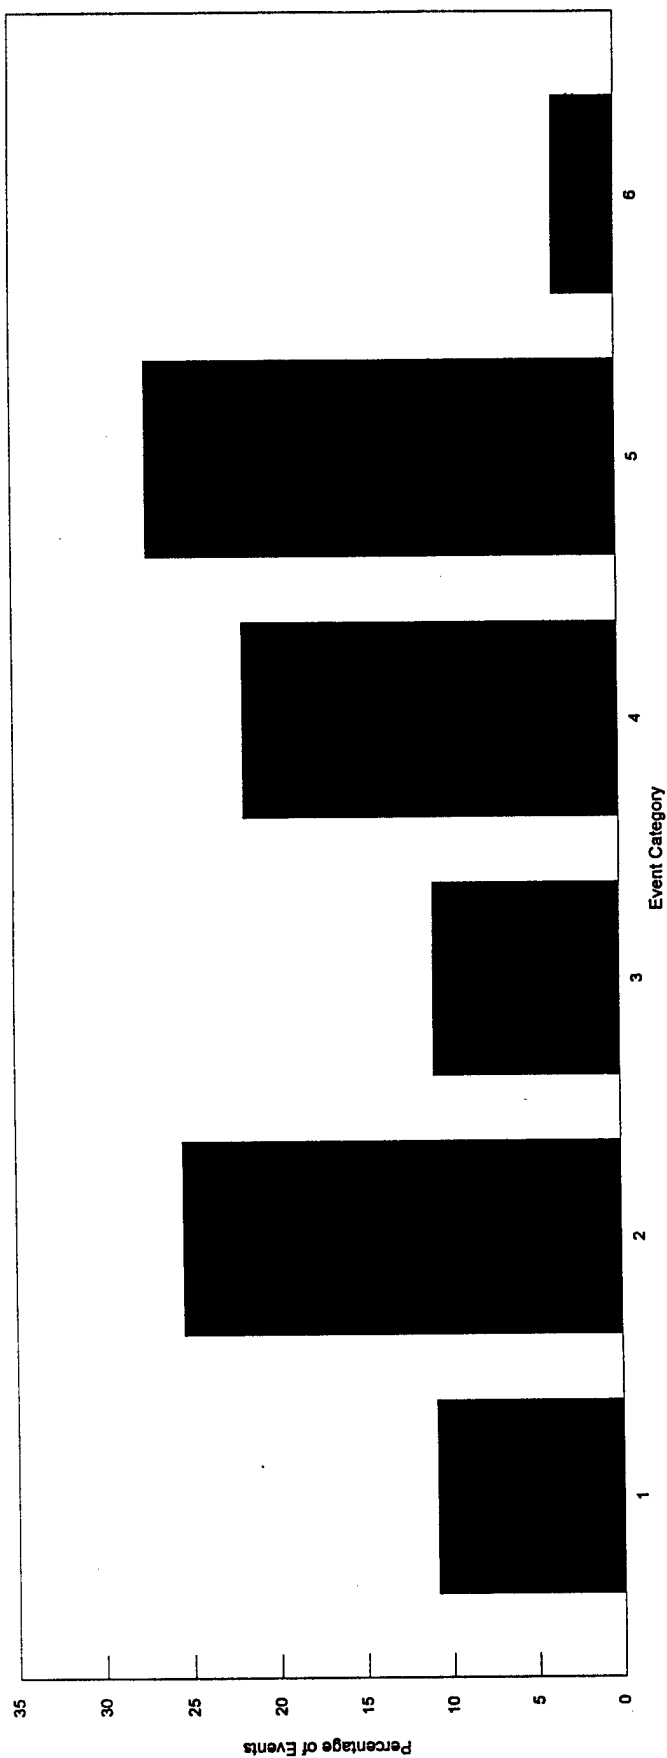
Figure 3.1 General Categories of Causes of Fuel Oil/Lube Oil Spray Fires

Spray fires have occurred because of a variety of human-related and/or equipment-related causes. Although each incident is unique regarding the specific cause of failure, it is convenient for the purpose of discussion to assign them to one of six general categories of causes of failure. Figure 3.1 presents the percentage of incidents that resulted from each general category. Next we discuss and illustrate each category.

Category 1: Lack of adequate inspection or maintenance. About 10% of all incidents in Appendix A involved lack of inspection and/or maintenance of equipment and piping, including incidents typically attributed to “aging,” “wear,” or “overdue for replacement.” We included these causes in Category 1 because equipment and piping will wear out over time because of erosion, corrosion, friction,

fatigue, vibration, etc., and it is essential to establish programs for inspecting and maintaining these components according to applicable industry guidelines. Otherwise, the equipment and piping are expected to eventually fail because of aging, wear, etc. In fact, for most incidents in this category, the event description indicates that there was no ongoing inspection and maintenance program for the equipment or piping. That is, the equipment and piping were under a “breakdown” maintenance program. In one of these incidents (Event 94175011, page A-101), there was a program for inspecting and maintaining lube oil piping systems for blowers, but the piping system for one of the blowers had not been inspected and maintained because it was inaccessible. The piping eventually ruptured because of corrosion and vibration, causing the blower to disintegrate.

Category 2: Personnel error during inspection or maintenance. Almost 25% of all incidents in Appendix A were associated with personnel errors and/or equipment failure during inspection or maintenance activities, and about half of these incidents resulted in human casualty. (Failure to use adequate personal protective equipment [PPE] is almost invariably mentioned as a contributing factor for human casualties.) Many of these events were caused by a lack of understanding of the design and operation of vessel systems and components. For example, in Event 1141196011 (page A-193), while trying to remove a valve handle, a crew member inadvertently removed two screws that secured the valve stem holding plate. The stem shot out of the valve, covering the crew member with oil and spraying oil in the machinery space. In Event 1342496001 (page A-213), during replacement of a temperature gauge, a thermo bulb was kinked and broke when it was moved, again spraying lube oil on a crew member. A third example is Event 95141027 (page A-145), which involved two crew members clearing a blocked gauge line with a thin wire. When they succeeded in unblocking the line, a hot mixture of soot and oil sprayed out onto the crew.

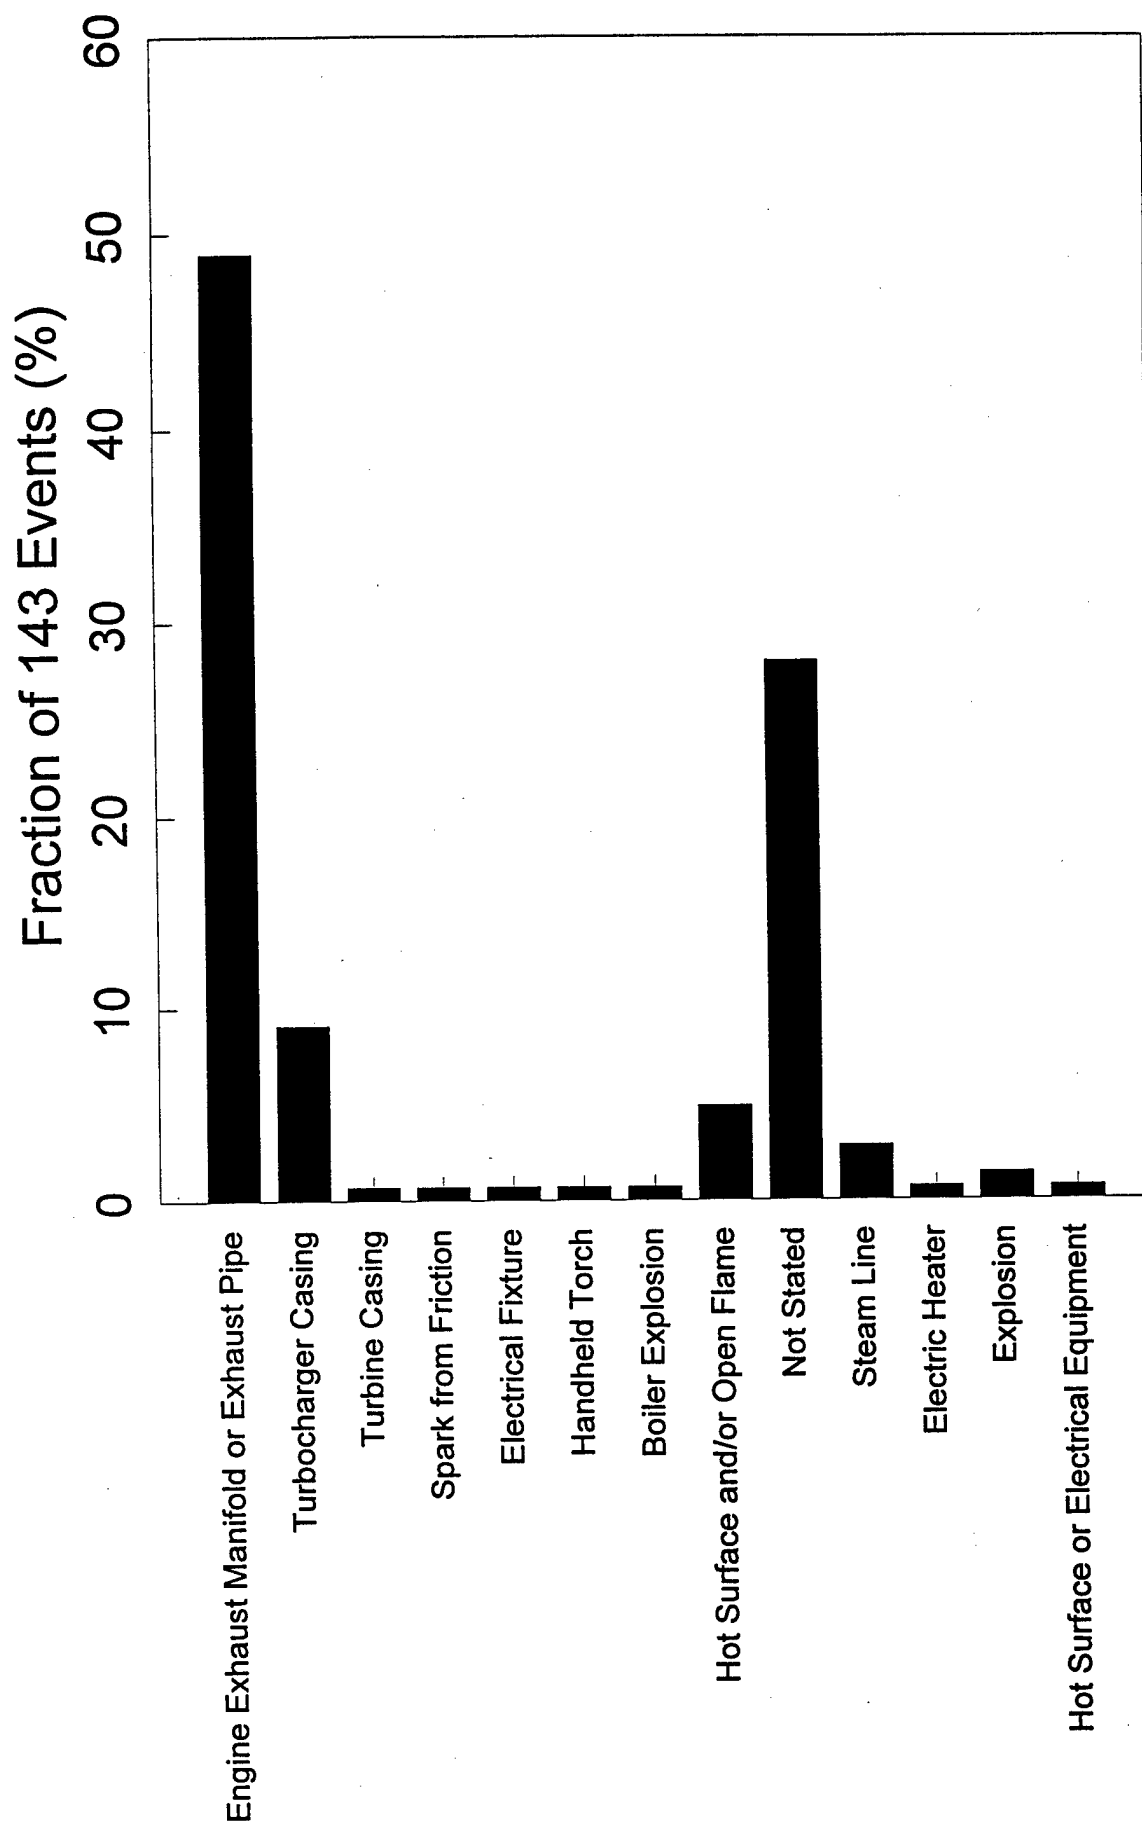
Figure 3.2 Source of Ignition: All Oil Fires

3.2 Sources of Ignition of Fuel Oil/Lube Oil Spray Fires — Figures 3.2 through 3.4 show the sources of ignition for the 143 spray fires, 17 spray fires with injury or fatality, and 9 spray fires with fatality, respectively. “Engine Exhaust Manifold or Exhaust Pipe” is by far the most common source of ignition (almost 50% of all fires in Figures 3.2 and 3.3 and about 22% of all fires in Figure 3.4). The “Not Stated” category is also an important contributor in all three figures. Other important contributors in all cases, particularly in Figure 3.4, are “Turbocharger Casing” and “Steam Line.” It is clear that hot surfaces dominate risks of ignition within engine rooms on board ships.

Table 3.2 shows a synopsis of the causes of each of the nine fatal fuel oil/lube oil spray fires. Appendixes A through G provide more details for some of these events. As shown in Figures 3.2 through 3.7, hot surfaces ignited most of these incidents. Thus, providing sheathing for hot surfaces or other means (e.g., deflector shielding) to prevent oil sprays from reaching hot surfaces should help reduce the frequency of these incidents.

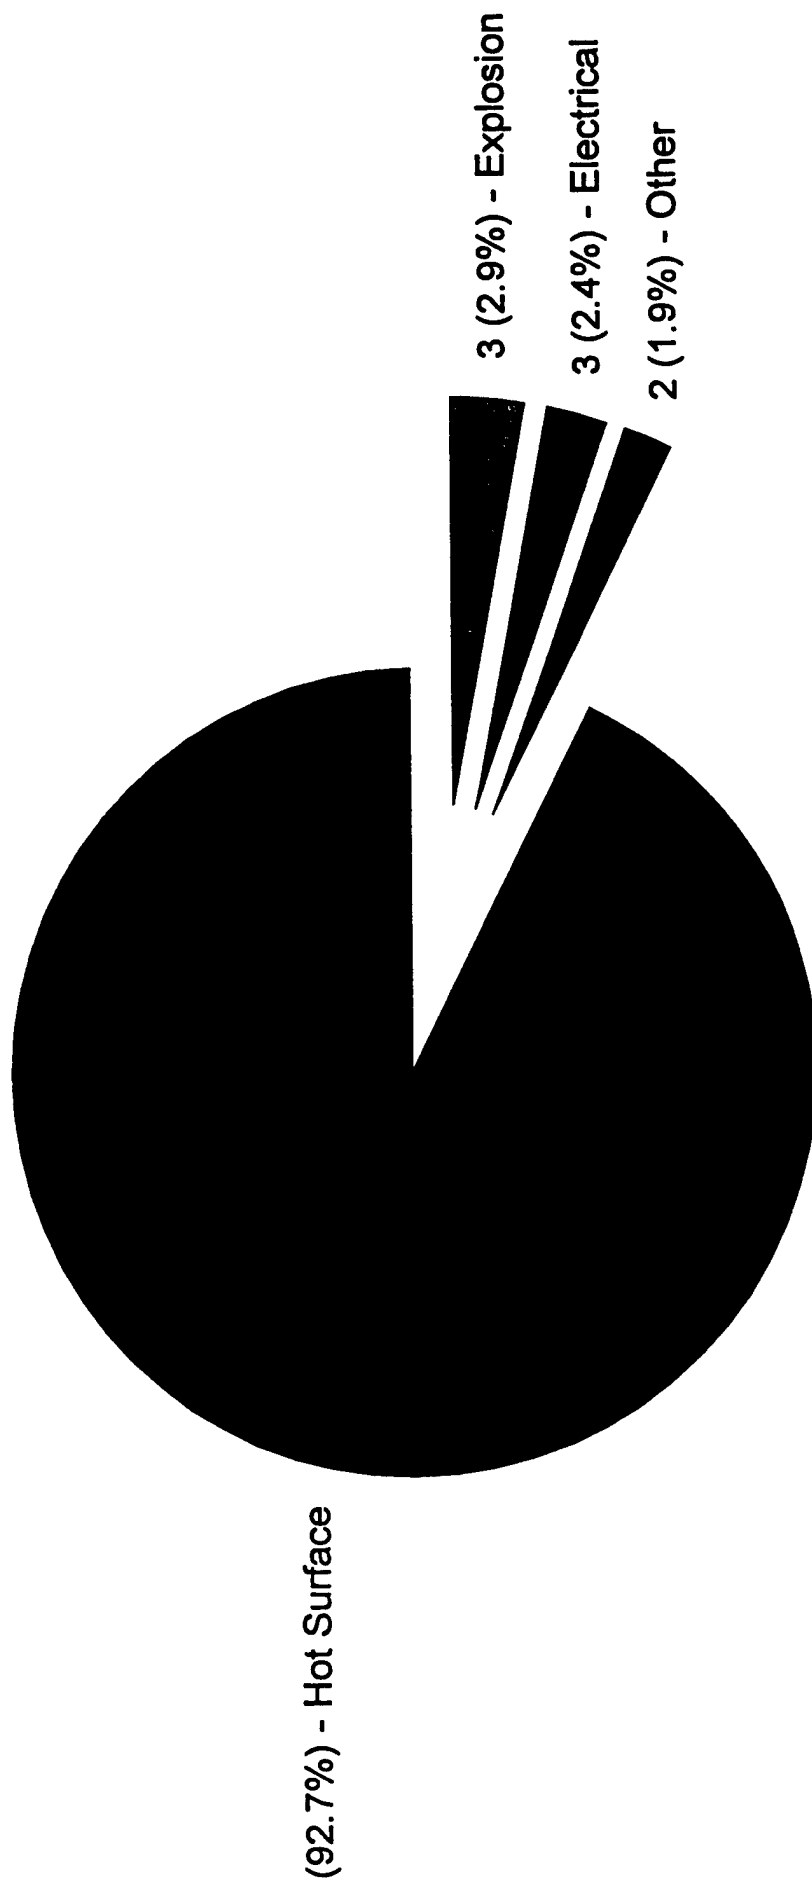
Figure 3.5 Sources of Ignition by Categories: All Oil Fires

To further illustrate the dominance of hot surface, Figures 3.5 through 3.7 show the relative contribution of categories of sources of ignition, defined in Table 3.1.

The category "Hot Surface" is responsible for the ignition of about 93% of all fires, 93% of all fires with injury or fatality, and about 86% of the fires with fatality. For the latter (fires with fatality), the one incident ignited by a handheld torch represents about 14% of all fires because there are only seven fatal fires in which the source of ignition has been determined and documented.

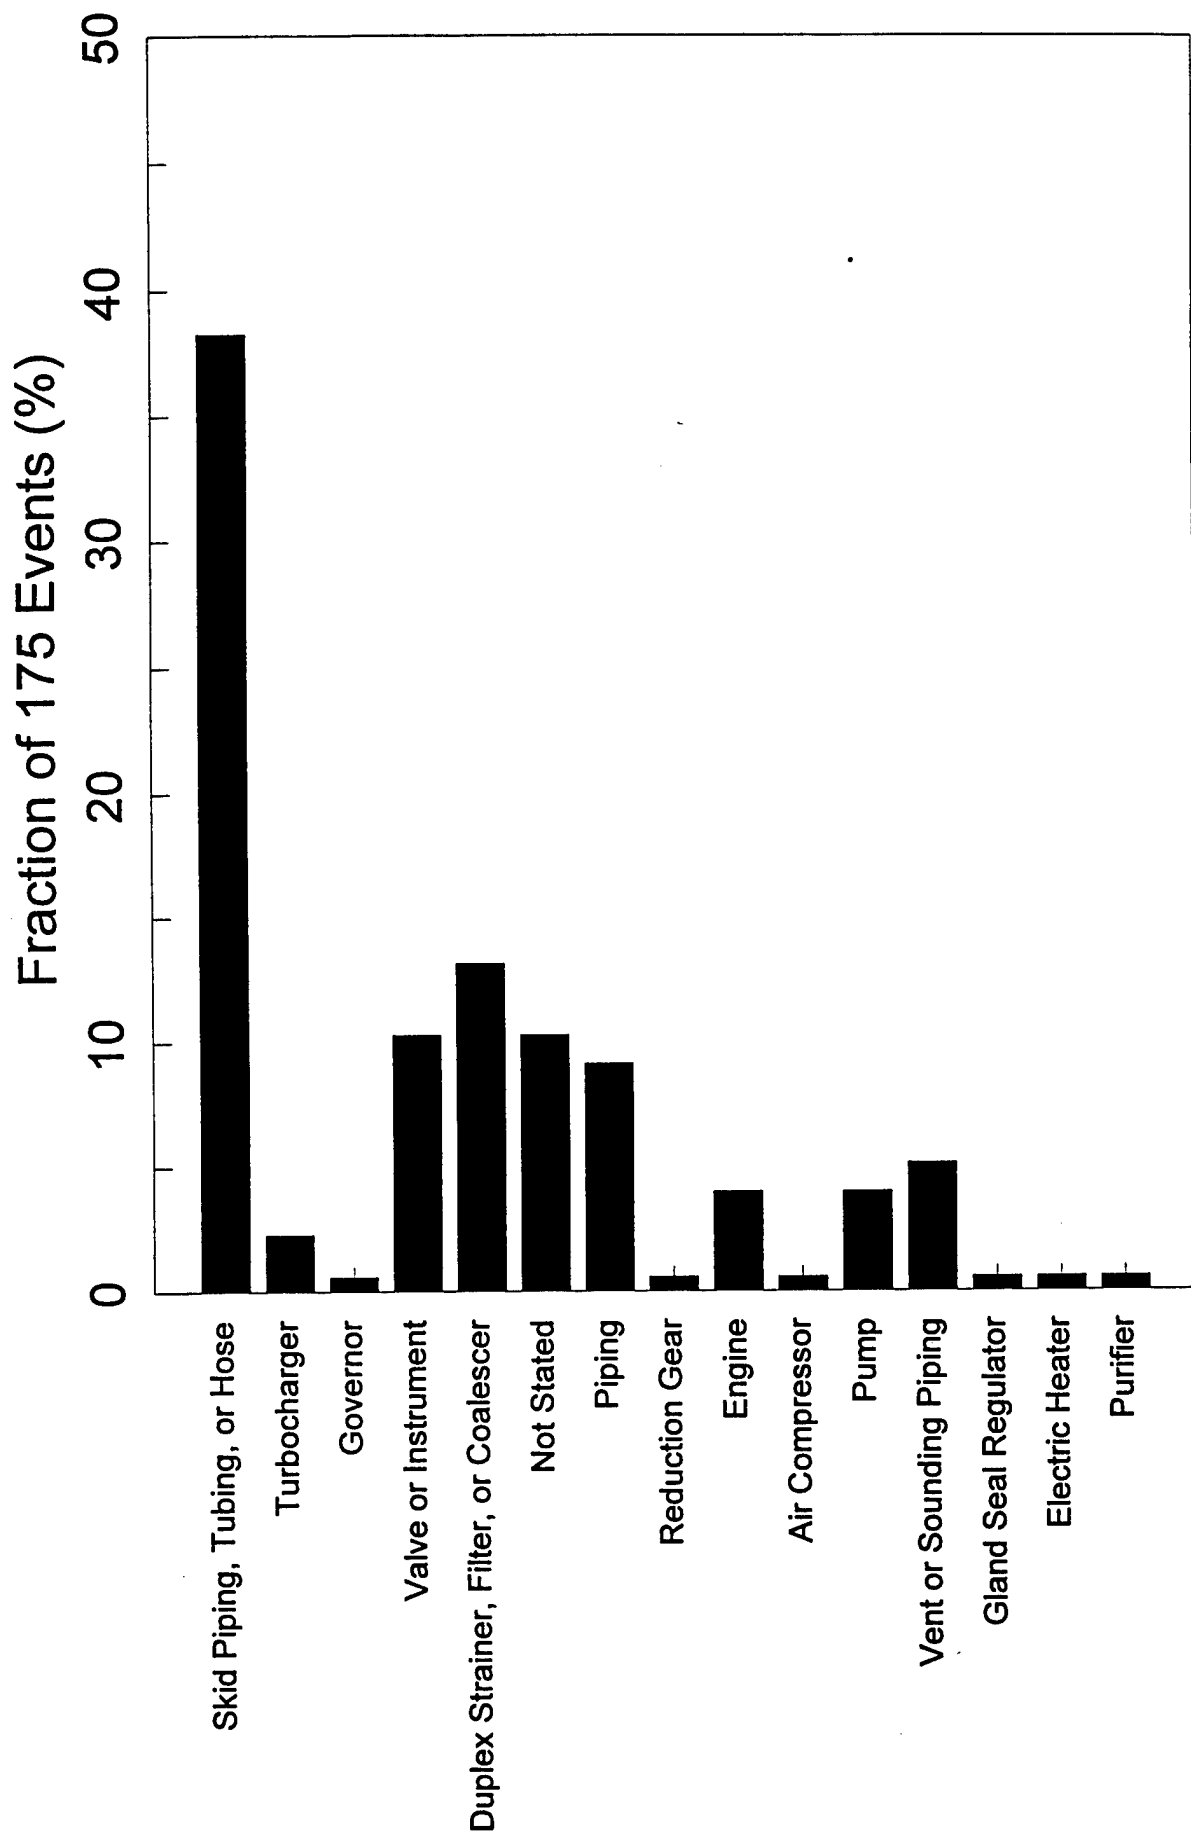
Figure 3.8 Equipment Involved in the Release: All Oil Releases

3.3 Equipment Involved in Fires Caused by the Release of Fuel Oil/Lube Oil — Figures 3.8 through 3.10 show the equipment involved in the release of fuel oil/lube oil and its contributions to all fire incidents (Figure 3.8), all fires with injury or fatality (Figure 3.9), and all fires with fatality (Figure 3.10), respectively. "Skid Piping, Tubing, or Hose" dominates risks in Figures 3.8 and 3.9, and it is important in Figure 3.10. (The piping outside the engine or pump skid [e.g., piping from oil tanks to strainers and piping from strainers to diesel engines] is considered separately in the category "Piping.") These results are interesting because skid piping/tubing/hose is usually under the control of the manufacturer (i.e., the piping/tubing/hose that comes with an engine skid or pump skid), and it is generally not subject to regulations and standards that are in place for piping outside the engine/pump skid.

However, the equipment category "Duplex Strainer, Filter, or Coalescer," which is the second most prevalent in Figures 3.8 and 3.9, dominates risks in Figure 3.10. *That is, spray fires involving "Duplex Strainer, Filter, or Coalescer" have been more fatal than fires involving other types of equipment.* In fact, the equipment category "Duplex Strainer, Filter, or Coalescer" is responsible for 55% of all fuel oil/lube oil spray fires with fatality (Figure 3.10).

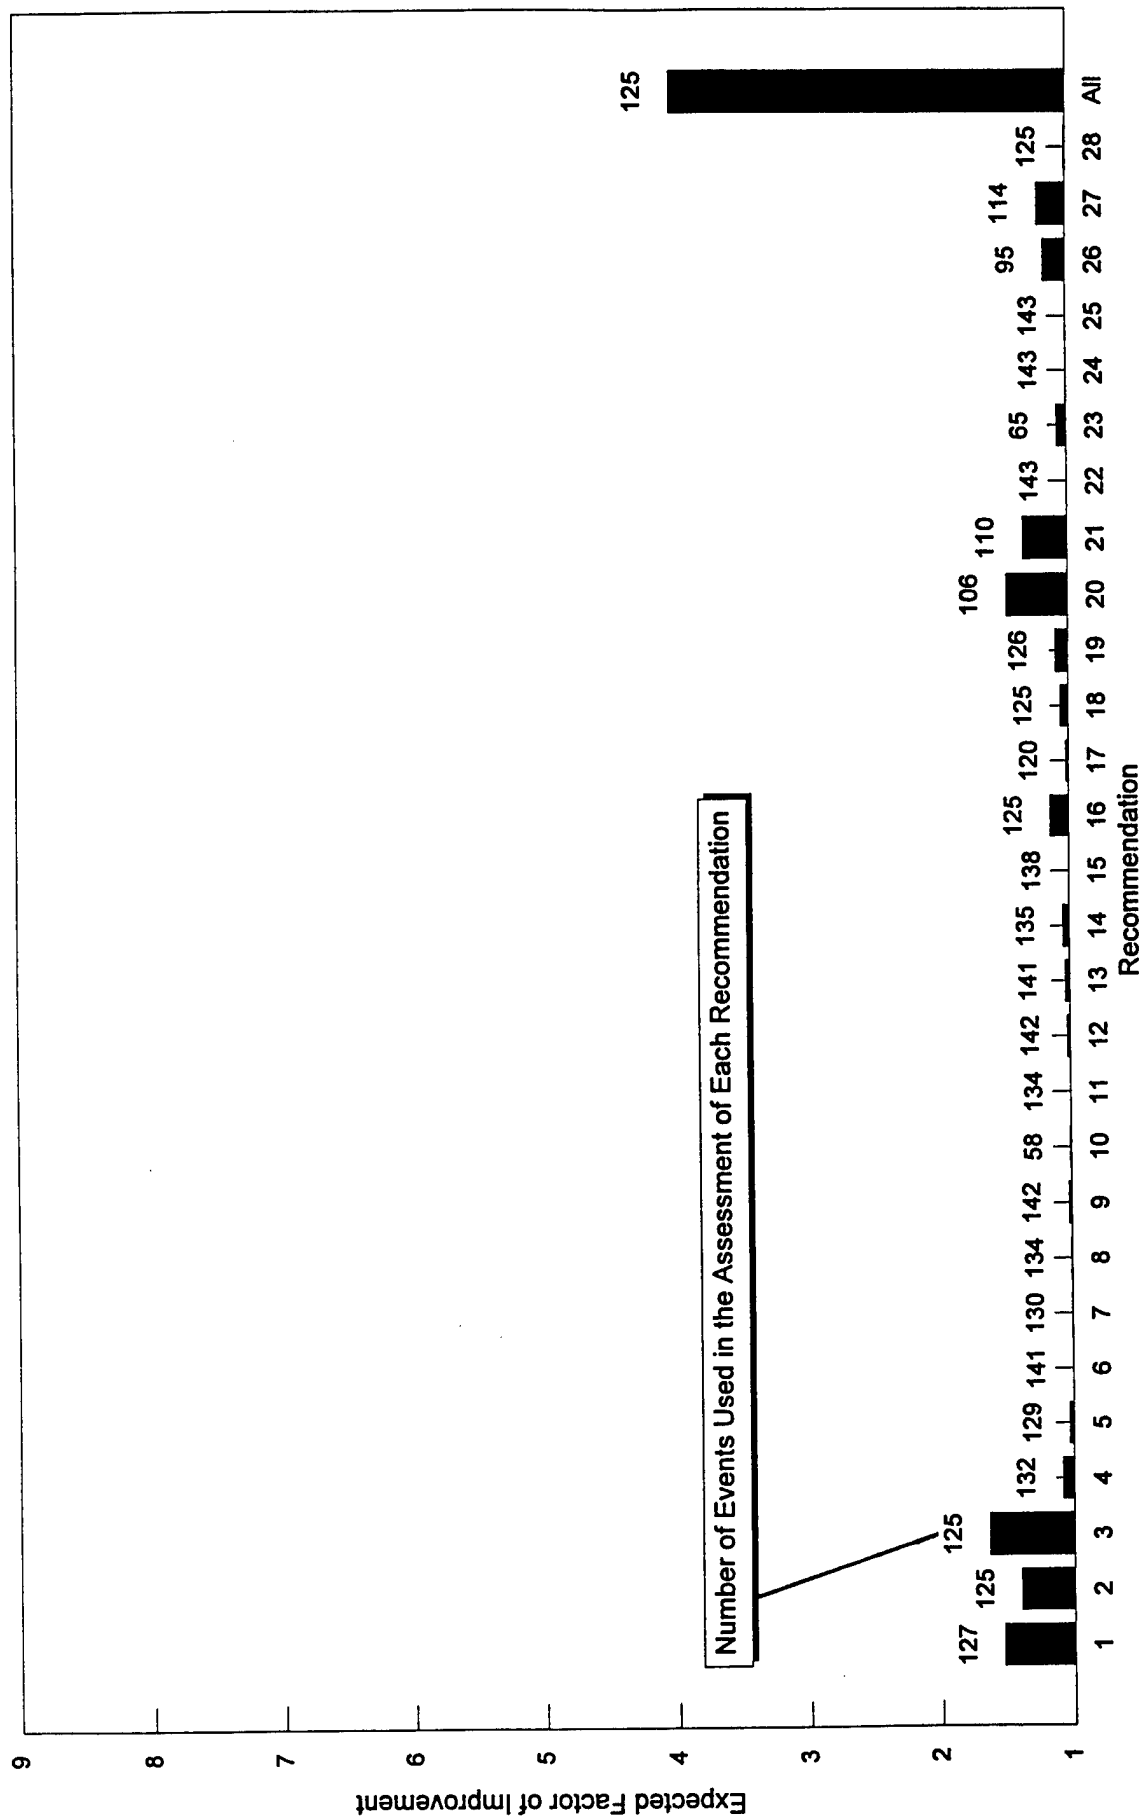
Figure 3.15 Expected Factors of Improvement for Preliminary Recommendations
(All Oil Fires)

3.6 Impact of Preliminary Recommendations — Figures 3.15, 3.16, and 3.17 show the expected factors of improvement for each preliminary recommendation (1 through 28) and for all preliminary recommendations combined (All) for all oil spray fires, all fires with injury or fatality, and all fires with fatality, respectively. In Figure 3.15, no single preliminary recommendation provides significant improvement (e.g., a factor of 2 improvement) by itself. (A factor of 2 improvement implies a 50% reduction of the frequency of incidents.) However, several preliminary recommendations (i.e., 1, 2, 3, 16, 20, 21, 26, and 27) do provide some improvements. The combined impact of all preliminary recommendations is a factor of 4 improvement (reduction of the frequency of incidents to 25% of its frequency without the benefits of these recommendations), primarily because of preliminary recommendations 1, 2, 3, 16, 20, 21, 26, and 27.

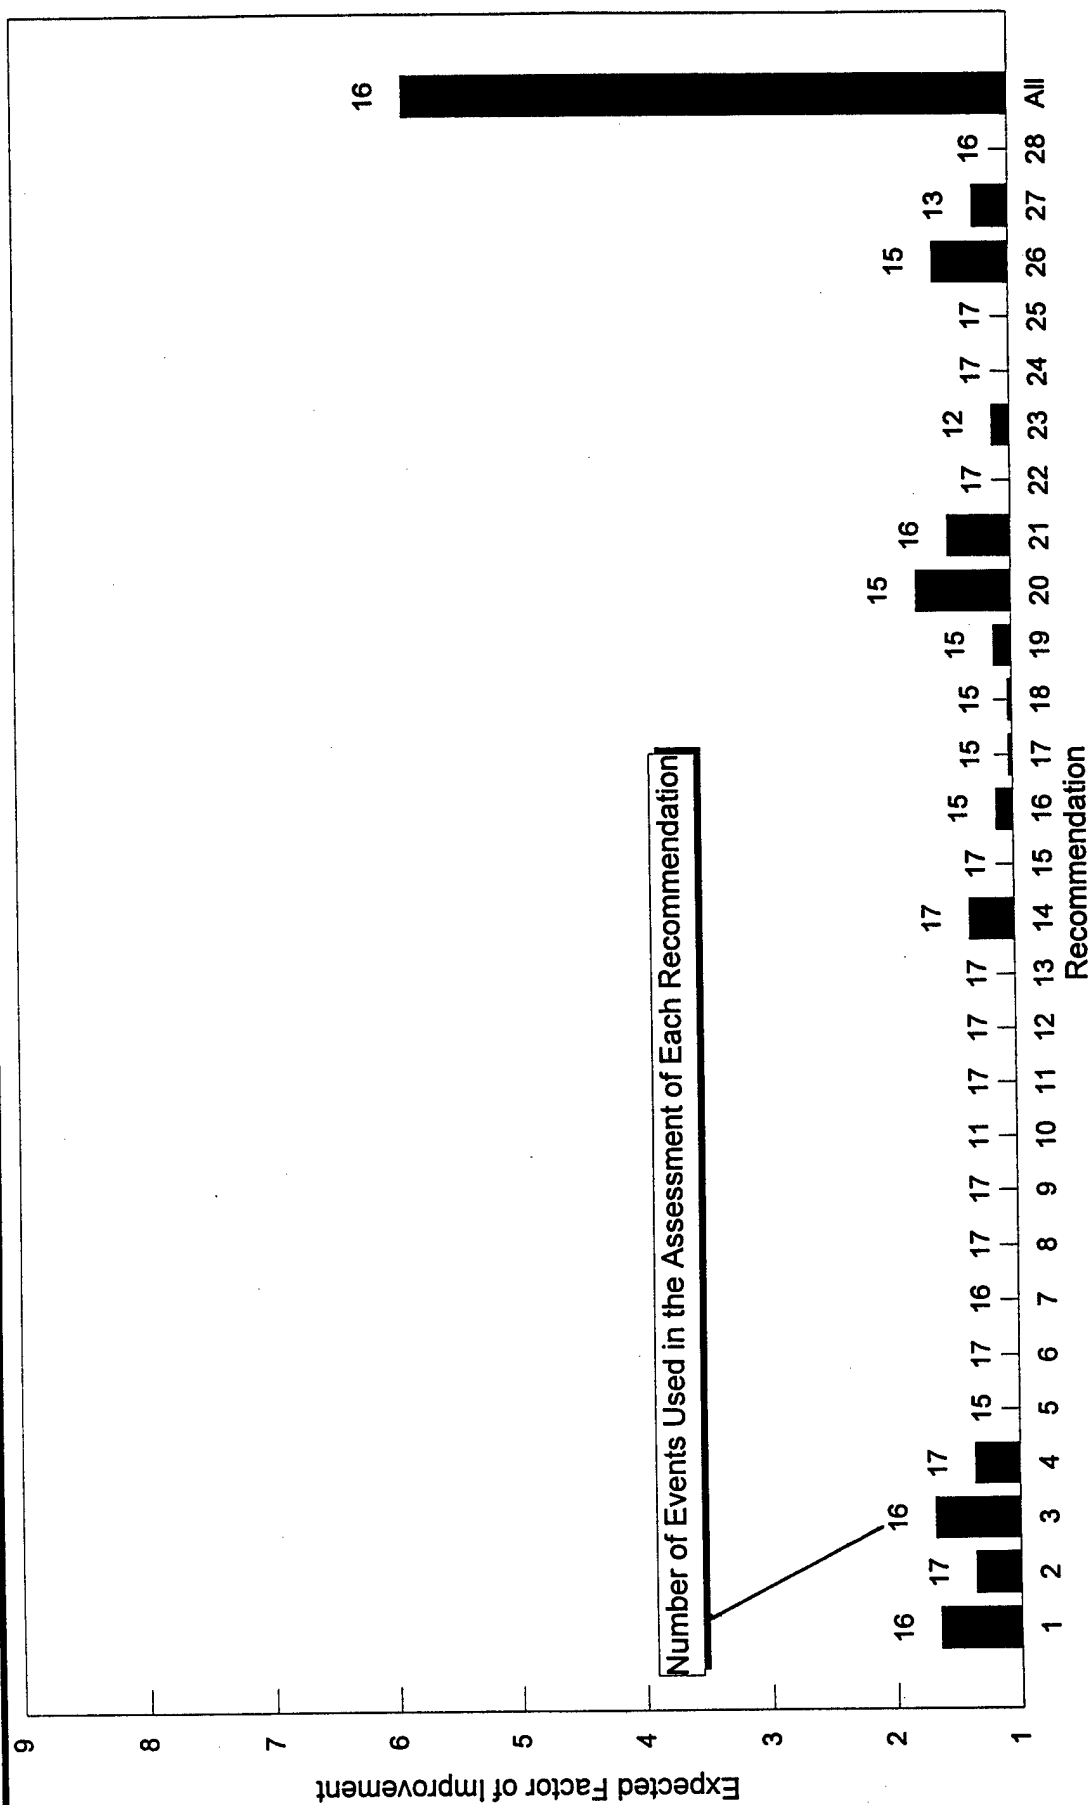
Figure 3.16 Expected Factors of Improvement for Preliminary Recommendations
(All Fires with Injury or Fatality)

Figure 3.16 shows similar results for the impact of preliminary recommendations on fires with injury or fatality. However, the individual impact of several recommendations is higher in Figure 3.16. Also, some preliminary recommendations (i.e., 4 and 14) that had little or no impact in Figure 3.15 show some benefits in Figure 3.16. The combined impact of all preliminary recommendations is a factor of about 6 improvement (reduction of the frequency of incidents to 17% of its frequency without the benefits of these recommendations), primarily because of preliminary recommendations 1, 2, 3, 4, 14, 16, 19, 20, 21, 23, 26, and 27.
